SUBJECT: Report No. 06-04, "Transportability Testing of the Joint Modular Intermodal Platform (JMIP)", TP-94-01, "Transportability Testing Procedures"

**TRANSPORTABILITY TESTING OF THE JOINT MODULAR
INTERMODAL PLATFORM (JMIP)
TP-94-01,
“TRANSPORTABILITY TESTING PROCEDURES”**

**Transportability Testing of the Joint Modular Intermodal Platform (JMIP)
TP-94-01, Revision 2, June 2004 "Transportability Testing Procedures"**

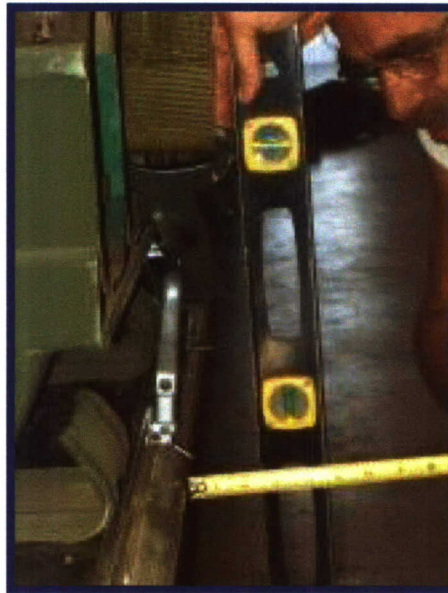
A. OBSERVATION. The pallets of 120MM Tank Ammunition with the tie-down straps in position exceeded the intermodal container door-opening dimension. When engaged in the tie-down ring the hook of the strap extended past the width of the JMIP. The overhang on the left side was 1.25 inches and on the right side was 2.375 inches. The overall width was 94.875 inches and the intermodal door opening dimension of the SEA BOX container was 92.5 inches. Therefore, the JMIP with payload was too wide to load the intermodal container.

Photo 1. Overhang of Hook.

B. CONCLUSION. The 120MM Tank Ammunition or similar wide load cannot be secured to the JMIP and transported in the intermodal container.

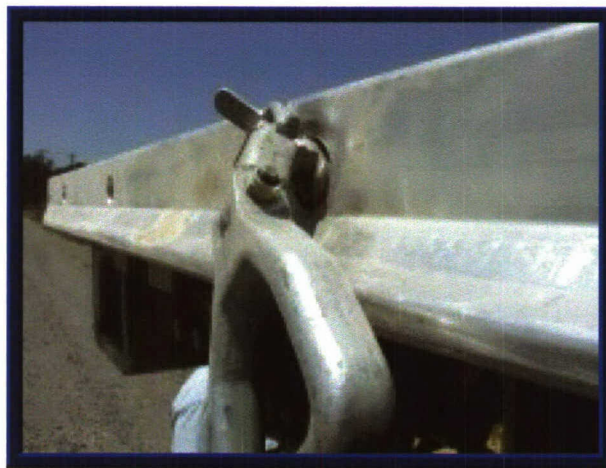
1. Inspection following the Washboard Course did not reveal any damage to the JMIP.
2. Unused tie-down ring along the side was loose and could easily be removed.

Photo 4. Loose Tie-down Ring.

3. All tie-down/lifting provisions on the JMIP must conform to MIL-STD-209, "Interface Standard for Lifting and Tie-down Provisions." Also, recommend that the cargo tie-down provisions be permanently attached.

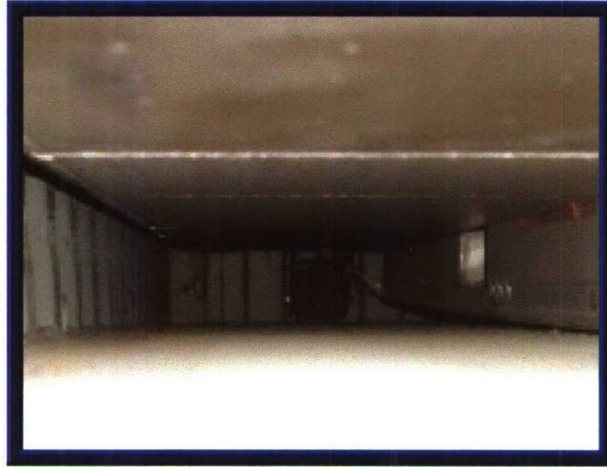
The rollers on the JMIP changed position during the PLS testing. Before the start of testing with the JMIP in the intermodal container the JMIP had to be removed and the rollers adjusted.

Photo 6. Rollers Holding the Main Rails off of the Container Floor.

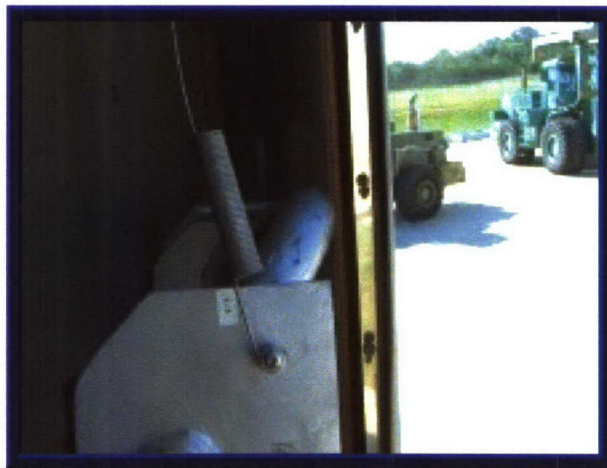
2. When inside the intermodal container the A-frame contacts the inside of the container door.

Photo 7. A-frame Contacting the Container Door.

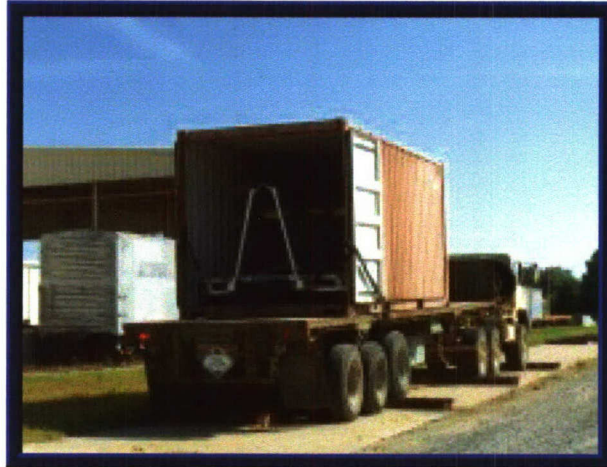
Photo 8. Hazard Course Testing of the SEA BOX JMIP

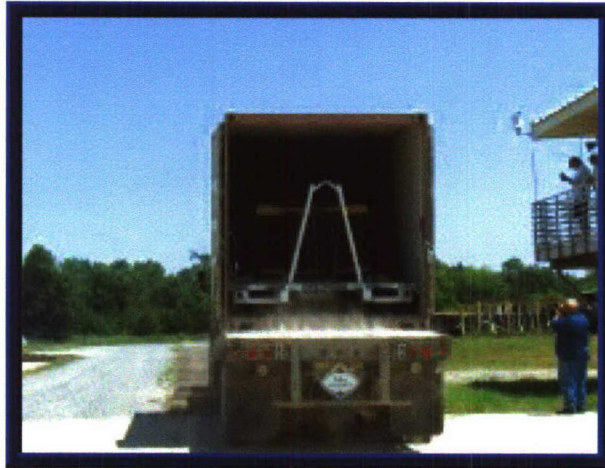
Photo 10. Washboard Course Testing of the JMIP.

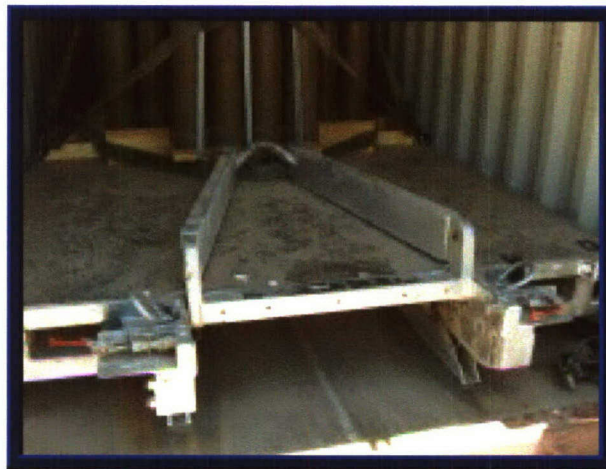
Inspection following completion of the washboard course revealed that the pins holding the A-frame in the "Container Transport" sheared. Following the failure of the pins the A-frame fell onto the JMIP deck.

Photo 11. Collapsed A-frame from Failed Pin.

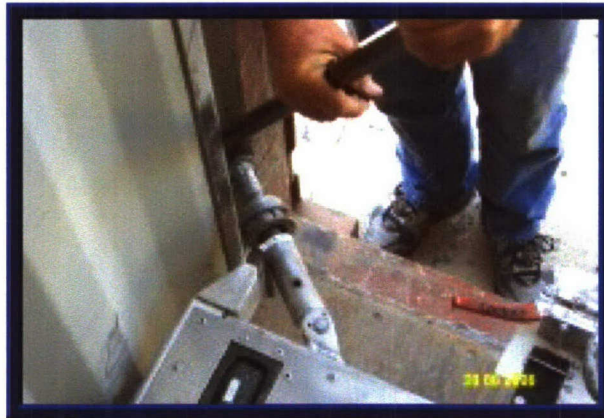
Following completion of the STS testing the one of the JMIP corner locks would not disengage properly. A hammer and pry bar had to be used to disengage the corner lock from the shoring slot.

Photo 12. Disengagement of Corner Lock of JMIP with Tools.

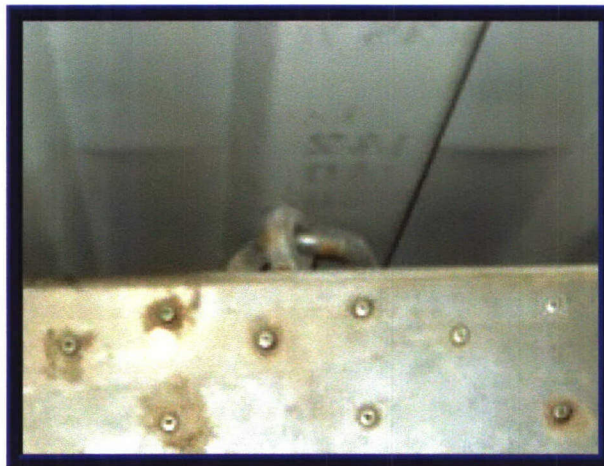
1. The JMIP rear tie-downs contacted the container wall and during testing damaged the container wall.

Photo 13. Contact of Tiedown with Container Wall.

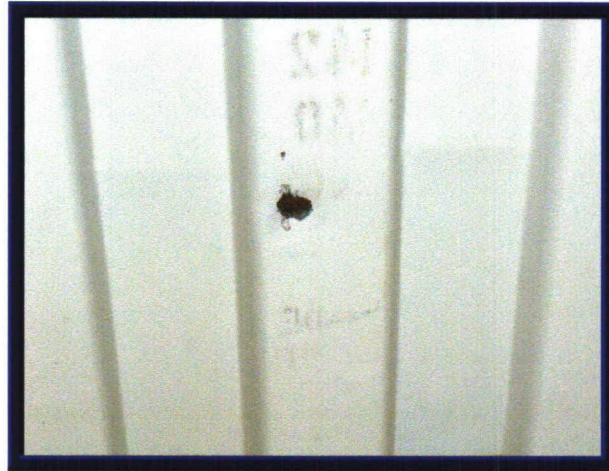
Photo 14. Damage to Container Wall from Tiedown.

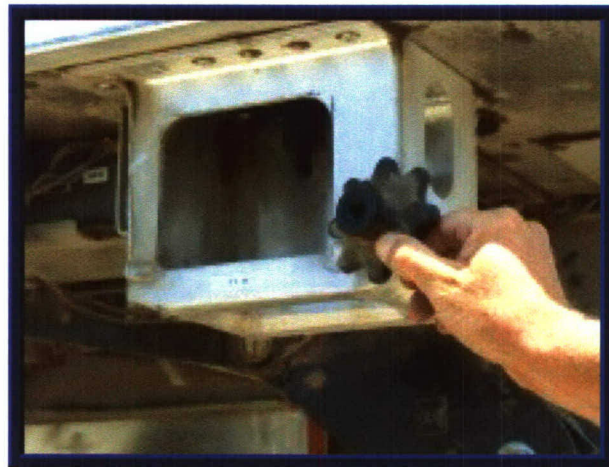
2. The handle for raising/lower the JMIP interlocks fell off during testing.

Photo 15. Loose Interlock Handle.

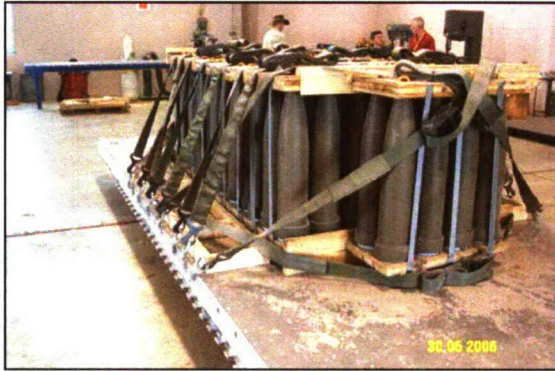
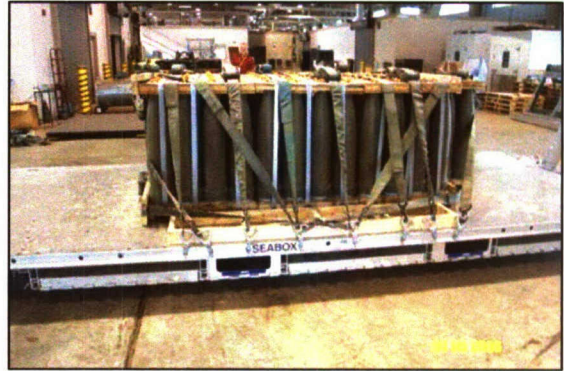
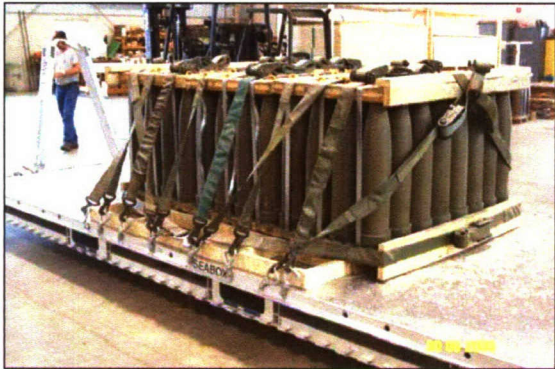
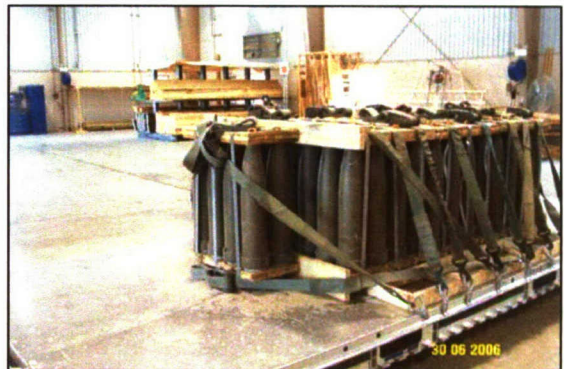
Photos of 155MM SLP Test Load (Modified from Test Sketch).
